# TN-USB-FX-01 Manual Update

## Driver Installation Note - Change “Speed and Duplex” to “100 Mbps Full Duplex”

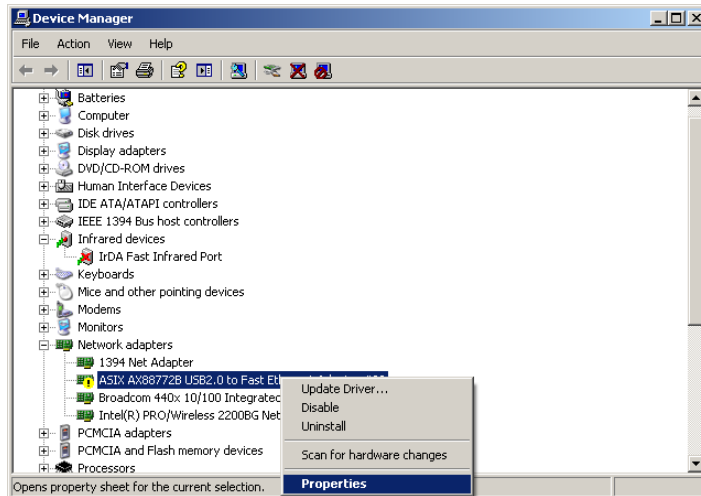
After you successfully install the driver, the TN-USB-FX-01 will work properly for a short time. To ensure continual operation, you must change the “Speed and Duplex Property Value” as described below.

1. In Windows, navigate to the Start > Settings > Control Panel > System > Device Manager > Network Adapters menu path.

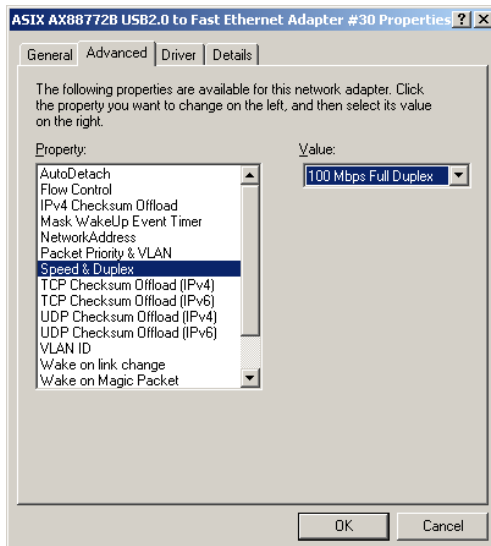
2. Select and right click the “ASIX AX88772B USB to Fast Ethernet Adapter” (the name of the chipset / manufacturer). The General tab displays the message “*Windows has stopped this device because it has reported problems. (Code 43)*”.
3. Select “Properties” and then select the “Advanced” tab.

4. At the “Speed and Duplex Property Value” dropdown, change the Ethernet link speed from “Auto Negotiation” to “100 Mbps Full Duplex”.
5. Click the **OK** button.
6. Unplug and replug the TN-USB-FX-01. The device will now run properly.
