## ERRATA: DTR SIGNAL

### Revision Tracking Information on XPort Direct Label

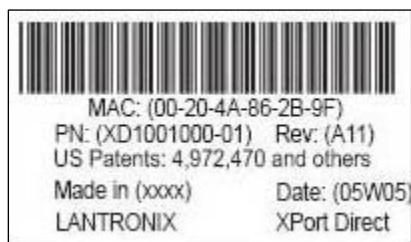
Please note that the revision information for the XPort Direct is located on the MAC label in the area shown as (A11) below:

All units with revision number C15 and greater will ship with firmware with the DTR signal correction. Units with revision number B14 and lower do not have firmware with the DTR signal correction; updated firmware for these units can be downloaded at:
